Article

Characterization of Natural Stone from the Archaeological Site of Pella, Macedonia, Northern Greece

Heritage **2021**, *4*, 4665–4677. <https://doi.org/10.3390/heritage4040257>

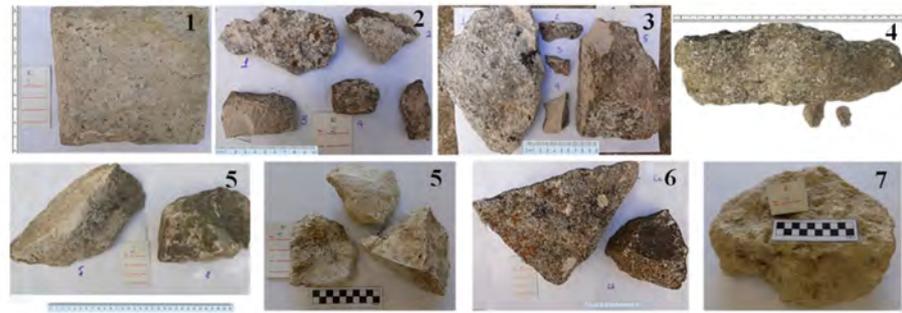
Figure 2. Stone samples collected from the seven sampling locations.

Sampling areas were selected according to macroscopic observation of the stones. Special care was taken to obtain representative stone pieces without affecting the structure of the archaeological monuments. Hence, samples were practically detached pieces that belonged to areas of low aesthetic and archaeological value. Curved or architectural parts were not selected for sampling. It is noted that due to the large area of the archaeological site and the large variety of the macroscopic characteristics of the stones (even within stones at a specific area), stone samples from the Palace of Pella area were not included in this study. Photographs of samples, which were investigated herein, are provided in Figure 2. The analyses that required a small sample size (e.g., microscopy, SEM-EDS) were performed for one sample from each of the seven locations. Physicomechanical measurements require large samples and, therefore, they were not carried out for all sampling locations. The analyses per sample that were performed herein are summarized in Table 1.

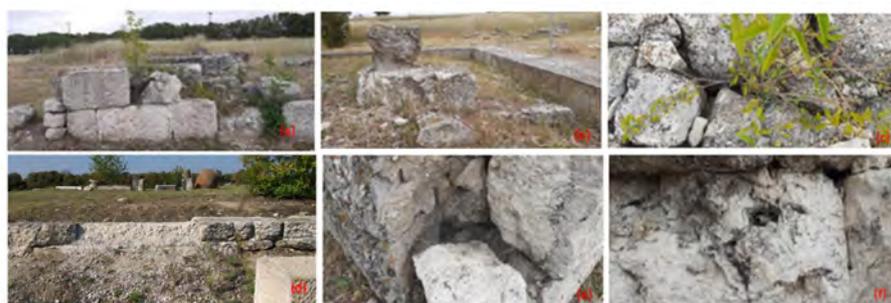
The on-site macroscopic examination revealed a variety of decay phenomena, such as peeling, biological colonization, disintegration, fragmentation and cracking, as shown in the photographs in Figure 3. Several portions of the stone structures exhibited local collapses and lacunas, indicating a variation of both the nature of the stone and the degree of deterioration, even between the stones that comprise a specific monument structure (Figure 3d). The absorption and stagnation of capillary water resulted in the significant swelling of the stones and, consequently, in the material degradation. The incoherent, porous and highly water absorbent stone materials allowed the formation and rooting of vegetation, resulting in further deterioration of the stone (Figure 3a,c). The existence of water in the bulk of the materials due to capillary water absorption, freeze–thaw cycles, dissolution and crystallization of salts can also result in partial dissolution–recrystallization of the carbonate material and loss of the structural cohesion and the surface stability of the stones. Water absorption, freeze–thaw cycles and biological colonization have been reported by Kouzeli (2009) [5] as the main factors contributing to the stone deterioration of the archaeological site of Pella. The exfoliation and fragmentation of the stone material were commonly observed, while the formation of long cracks, associated with the action of frost, was also recorded.

Figure 3. (a–f) The state of preservation of the building stone at the archaeological site of Pella.
